# MILDURA RURAL CITY COUNCIL

Low Cost Implanted  
Compact Roundabout  
Evaluation

**REPORT NUMBER:** S20200280-REP-01

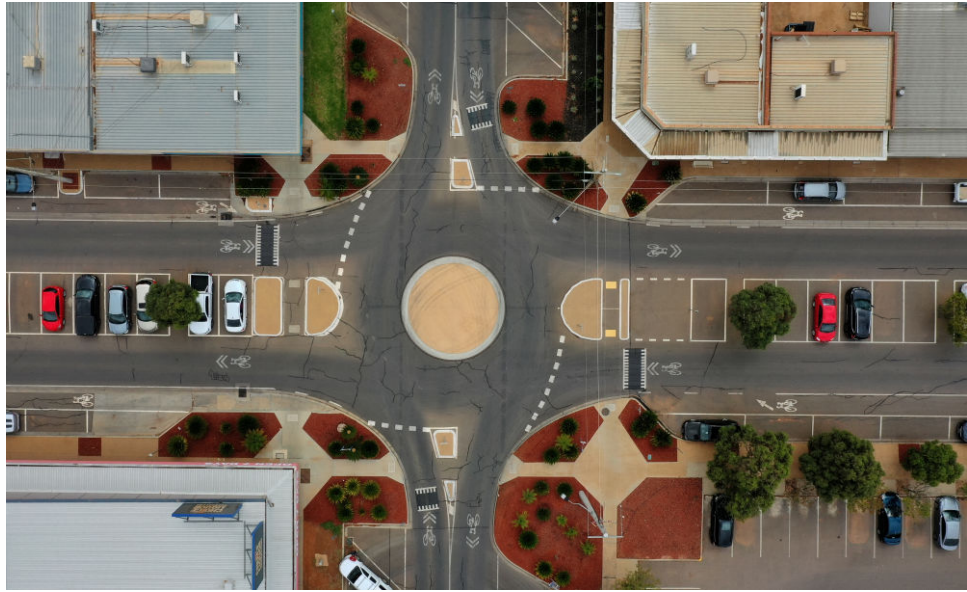
**Figure 1:** Low Cost Implanted Compact Roundabout

Mildura City Council has implemented a Low Cost Implanted Compact Roundabout (LCIC roundabout) at the intersection of Eighth Street and Pine Avenue in Mildura. This roundabout used a non-standard alignment by not realigning lanes to include reverse curves or entry curves. It also used non-standard traffic calming features (speed cushions) for roundabout locations, and a non-standard approach to construction to provide the final product at a significantly more cost-effective investment than typical roundabout installations (about one tenth of the price of a standard roundabout). This roundabout deviates from typical roundabout design and re-evaluates roundabout design from first principles. This approach was taken to identify how the safety benefits of a roundabout can be achieved with a retrofitted roundabout with minimal investment to obtain the desired speed outcomes.

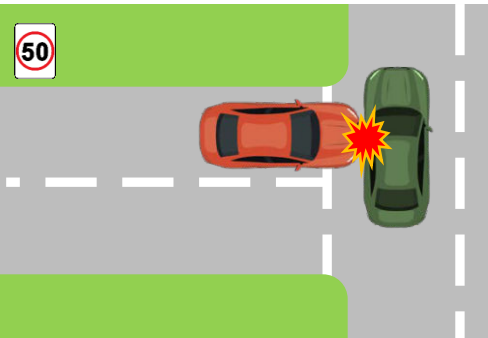
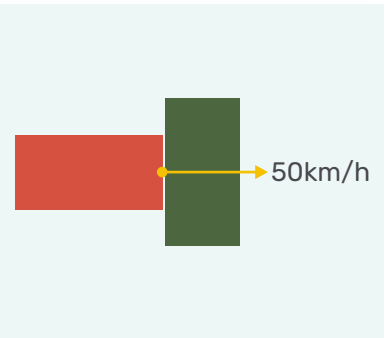
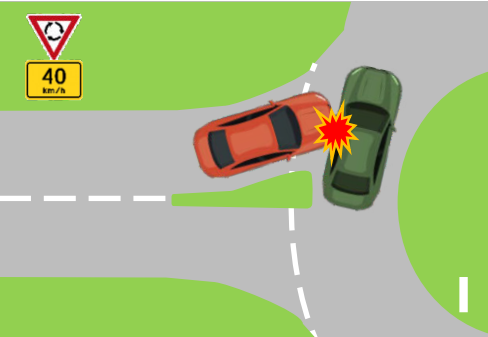
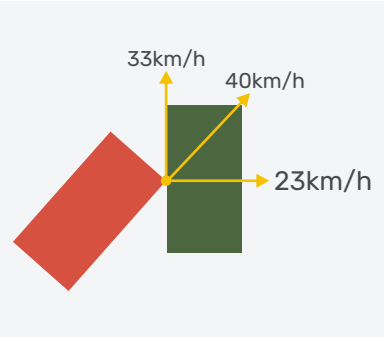
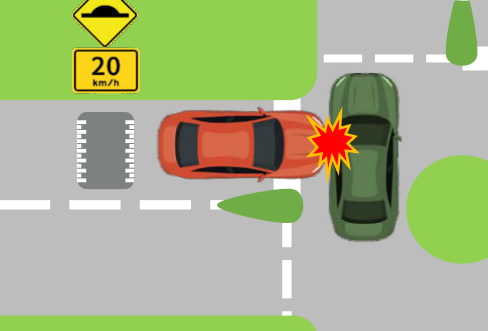
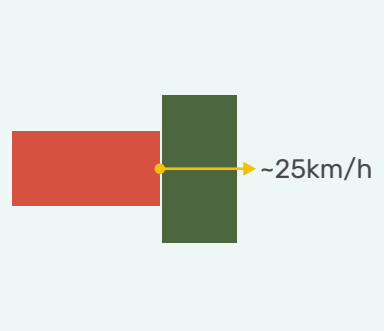
Resultant Lateral Forces from Various Intersection Configurations

Intersection Type	Crash Diagram	Crash Force Diagram	Resultant Lateral Speed
Cross Intersection

50km/h
Standard Roundabout

23km/h
LCIC Roundabout

~25km/h

intersections. However due to the greater speed reduction created by the speed cushion at the entry to the intersection, the resulting crash forces are expected to still provide a similar crash outcome in comparison to a standard roundabout as shown in **Table 1**.

Note that the angle of the entry curve at standard roundabouts is variable and can therefore result in some variation to the conversion between the actual vehicle speeds and the lateral speed component. The force diagram presented in **Table 1** assumes an impact angle of 30 degrees. Although shallower angles can be applied, this angle was taken to conservatively represent the majority of roundabout entry configurations. The angle of impact is calculated between the initial trajectory of the two vehicles.

the expected speed of ~25km/h from **Table 1**, indicating that the safety outcomes in the practical application appear to outperform the theory in terms of safety outcome.

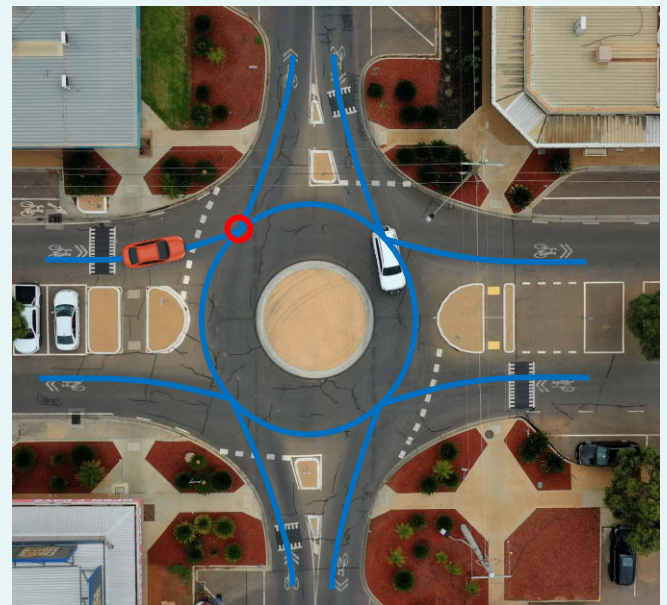
**Figure 3:**

Roundabouts simplify decision-making by limiting potential conflict points to one location when looking for a gap in traffic, as opposed to a typical T-intersection or cross intersection where there may be multiple conflict locations to consider. By consolidating conflicts to one location, the cognitive load on motorists is reduced and decision making for gap selection is improved. Note that additional conflict points would exist for multi-lane roundabouts.

The reduction in conflict points is achieved by creating a one-way circulating carriageway within the roundabout and requiring all approaches to give-way. These elements are consistent between standard roundabouts and the LCIC roundabout. No modifications to this arrangement were required for the LCIC roundabout to achieve the benefits associated with this principle.

Conflict Points for Priority Controlled Intersections (left); Roundabouts (right)

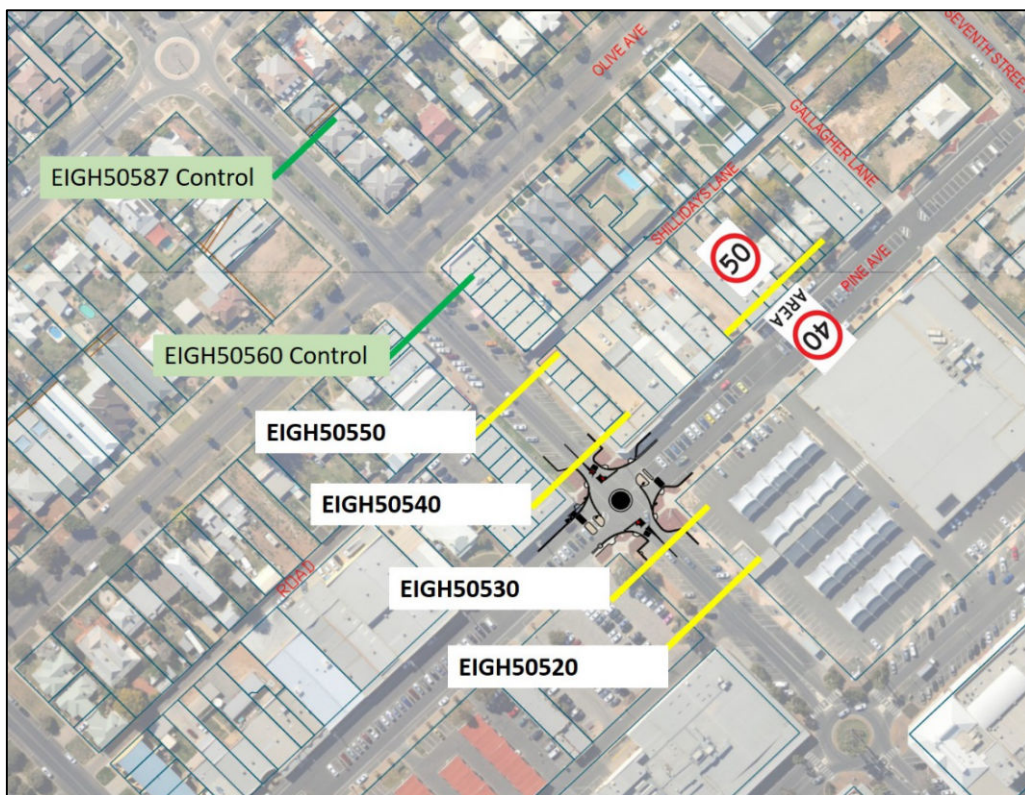
## EIGH50520 Pre-Construction

**Site:** [EIGH50520] G\_Eighth Street from Nash Lane to Pine Avenue <50>  
**Attribute:** MILDURA

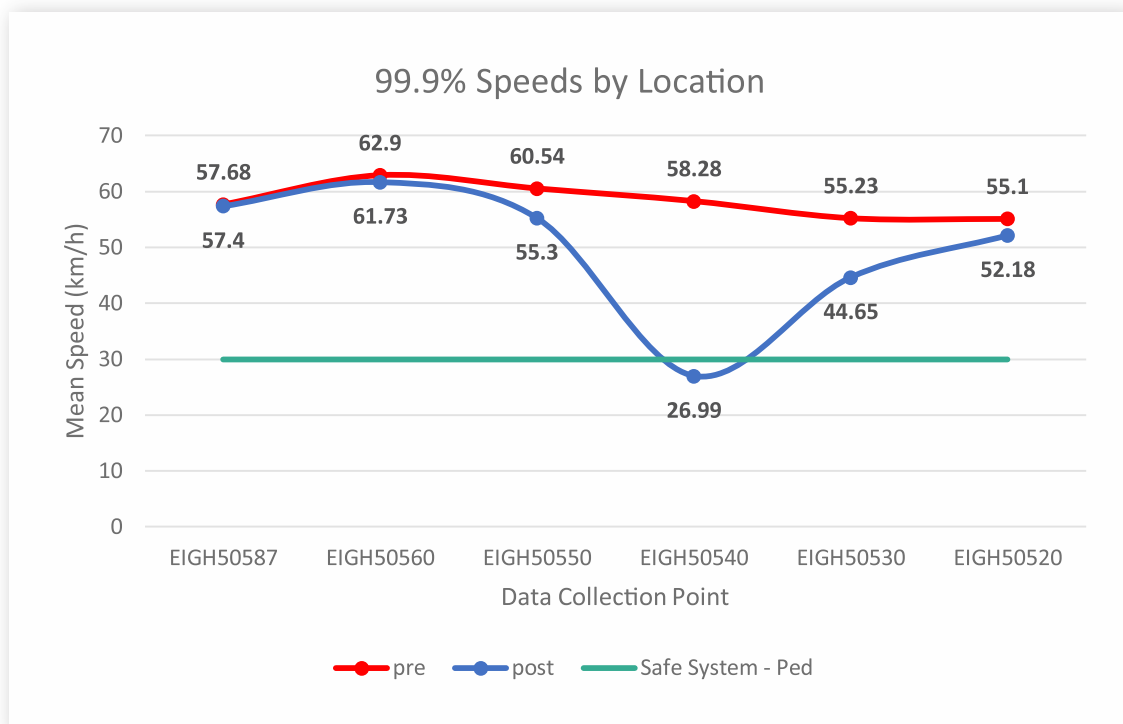
## Mean speeds and Upper Limit Speeds at 3 Standard Deviation

SD 3 speeds			
Location	pre	post	Safe System - Ped
EIGH50587	57.68	57.4	30
EIGH50560	62.9	61.73	30
EIGH50550	60.54	55.3	30
EIGH50540	58.28	26.99	30
EIGH50530	55.23	44.65	30
EIGH50520	55.1	52.18	30
