RAISED PEDESTRIAN CROSSINGS – ‘WOMBATS’

Wombat Crossings? It must be a sign.

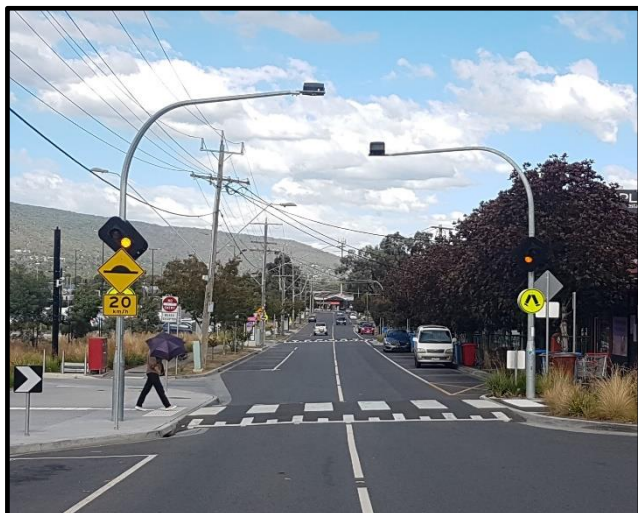
However, too much signage can also be a problem as it leads to sign cluttering. This is the reduced visibility to signage that sometimes occurs when there are a number of signs in close proximity. Some wombat crossings are signed with multiple pedestrian crossing, road safety platform and advisory speed signs. Drivers approaching these wombat crossings may not be able to process all the information as they approach these wombat crossings, or even have their vision to some signs obscured by others. The photo on the right shows an example of sign cluttering. You can see the Road Hump warning sign obscures the view of the pedestrian crossing sign.

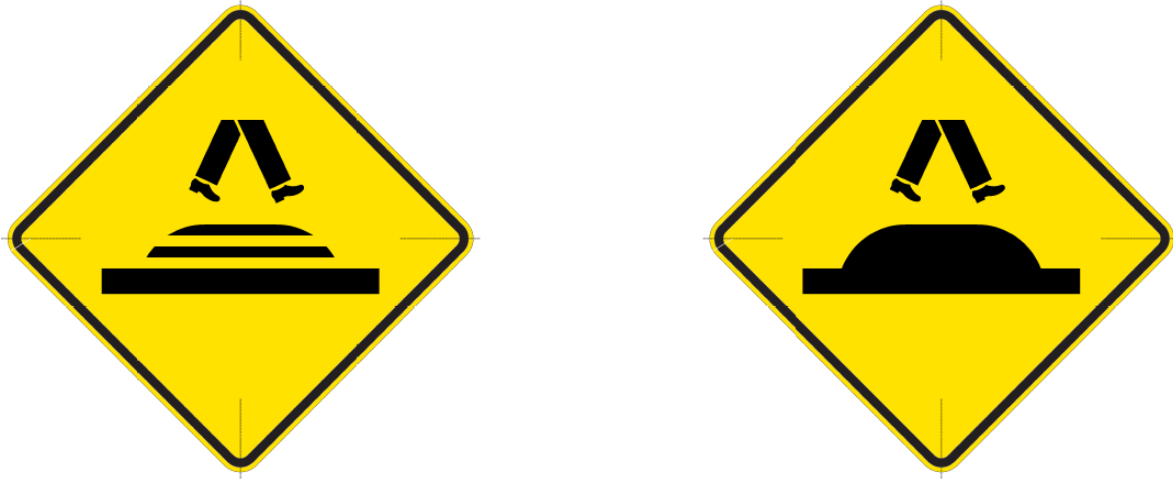
One potential solution is a new advance warning sign to be used exclusively at raised pedestrian crossings such as wombats. The challenge was creating a sign to let motorists know they were approaching a raised zebra crossing specifically. Here is an early concept:

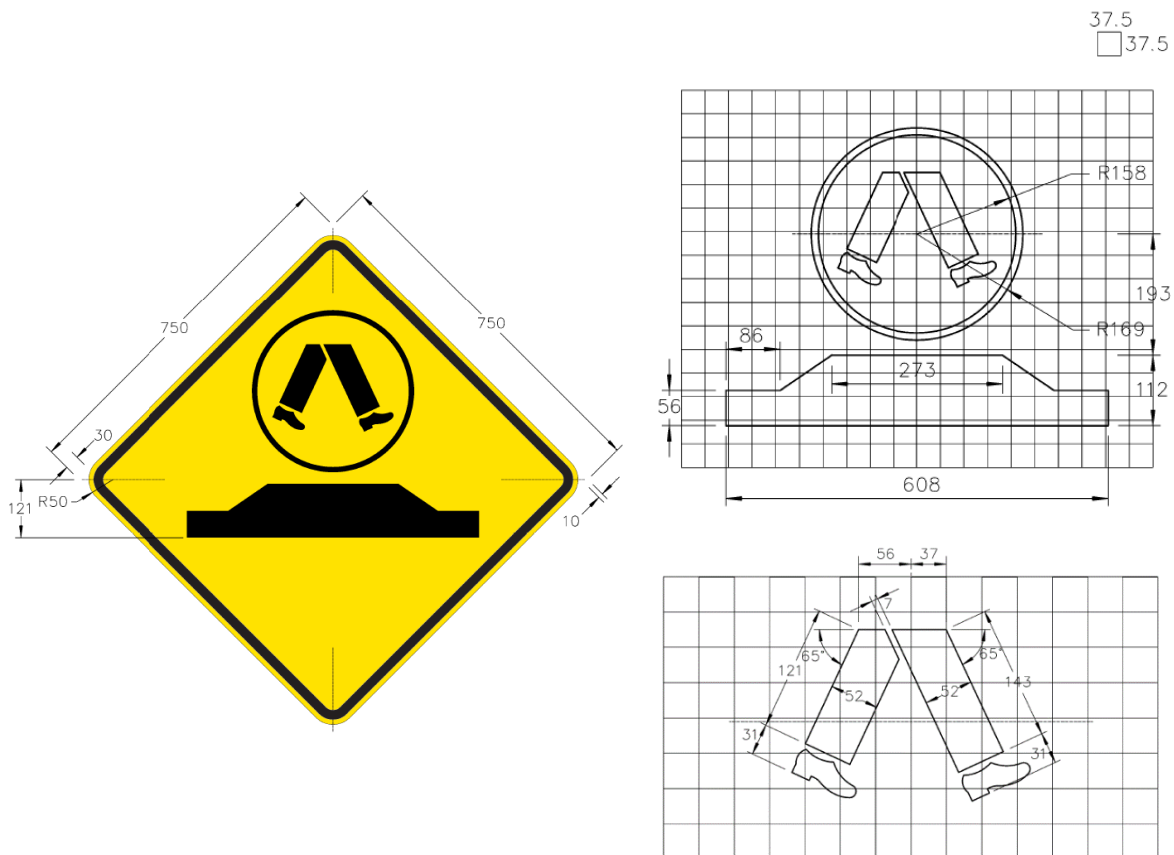
We then decided that the main focus of the sign should not be on the zebra crossing, and instead be on the pedestrian crossing on top of the raised platform. Here is a warning sign concept that we have designed:

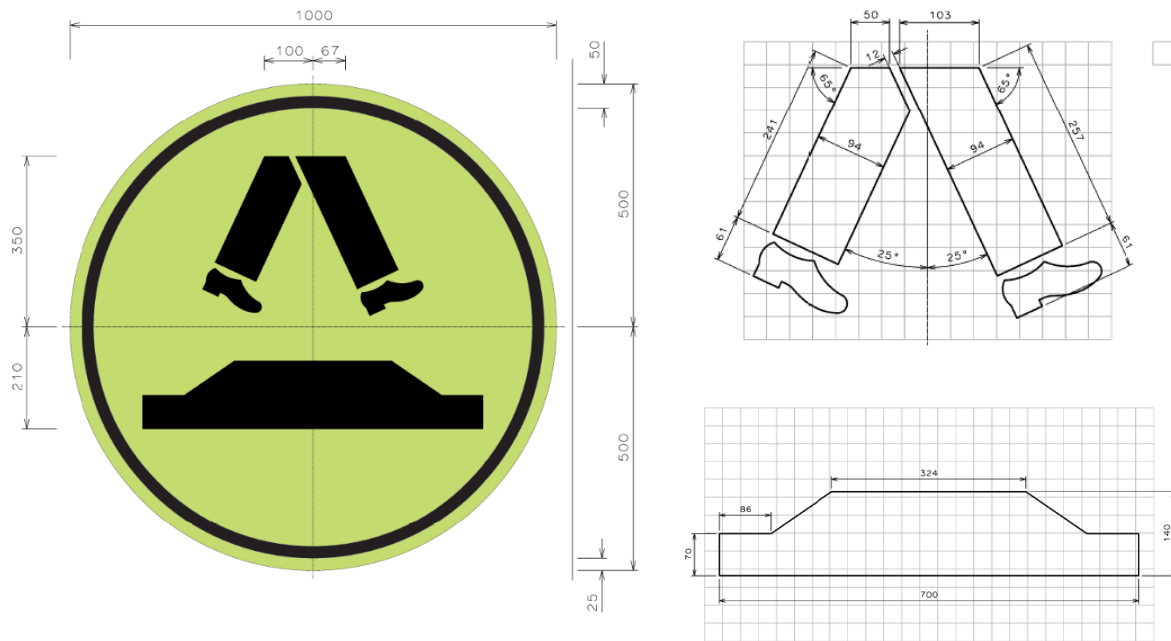
The above is a potential wombat crossing regulatory sign that we have designed. It essentially combines the pedestrian crossing and road safety platform signs onto a single sign face, which would reduce sign clutter and alert motorists to the raised nature of an upcoming pedestrian crossing.

This is just a concept at this stage, there would be many levels of approval required, including changes to regulations, standards and guidelines, but we're interested in what the traffic engineering community thinks about this concept?
