RAISED PEDESTRIAN CROSSINGS – ‘WOMBATS’

Wombat Crossings? It must be a sign.

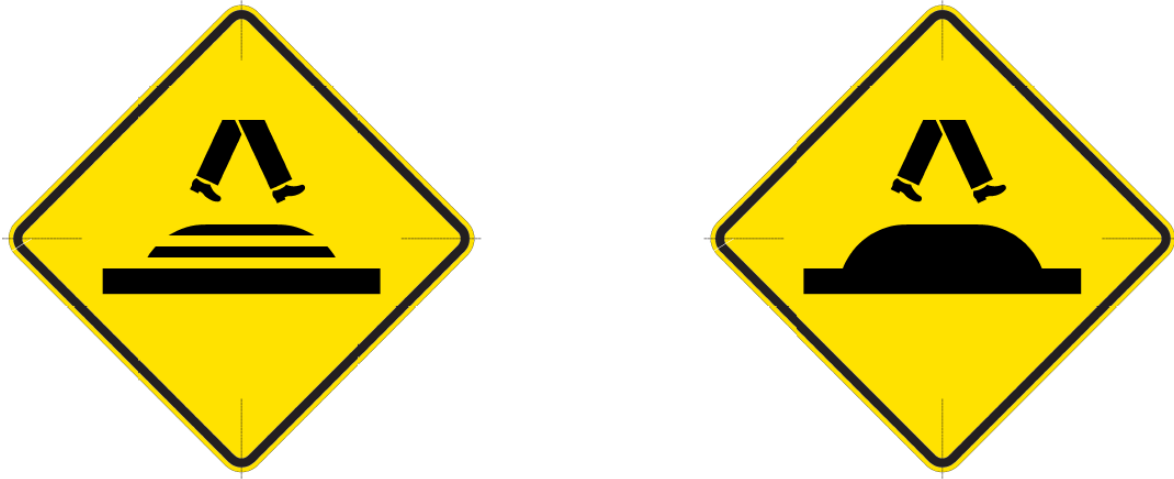
One potential solution is a new advance warning sign to be used exclusively at raised pedestrian crossings such as wombats. The challenge was creating a sign to let motorists know they were approaching a raised zebra crossing specifically. Here is an early concept:

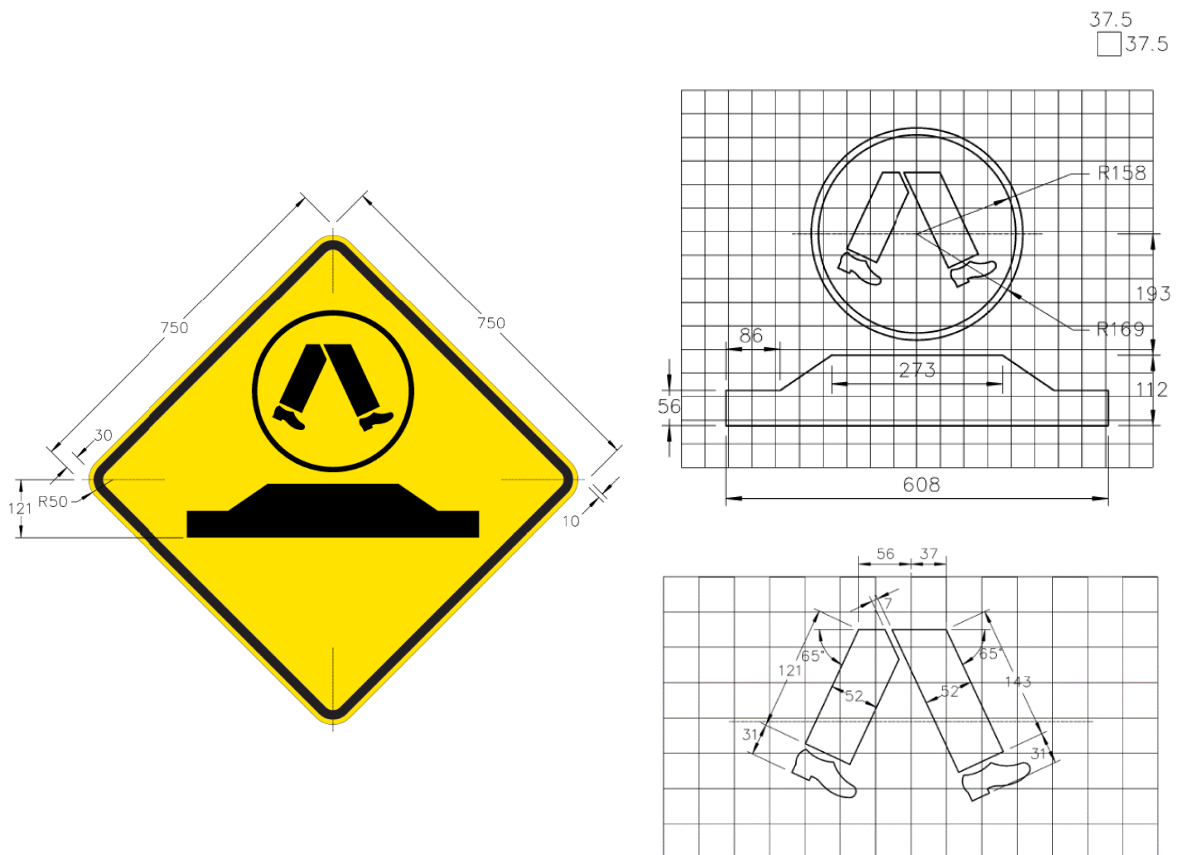
We then decided that the main focus of the sign should not be on the zebra crossing, and instead be on the pedestrian crossing on top of the raised platform. Here is a warning sign concept that we have designed:

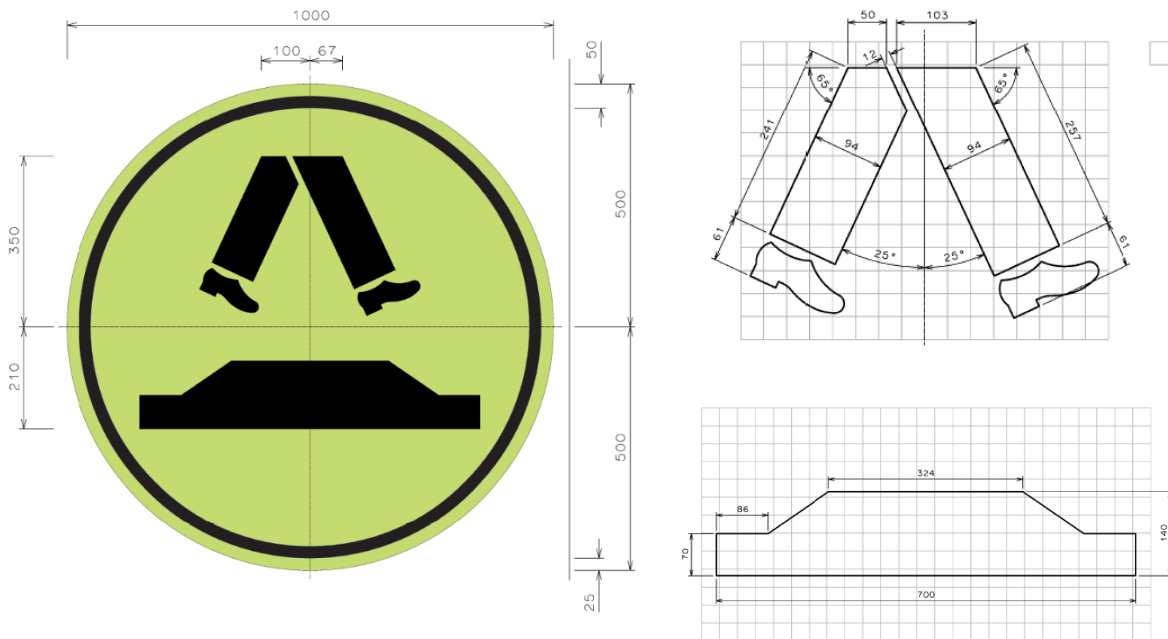
The above is a potential wombat crossing regulatory sign that we have designed. It essentially combines the pedestrian crossing and road safety platform signs onto a single sign face, which would reduce sign clutter and alert motorists to the raised nature of an upcoming pedestrian crossing.

This is just a concept at this stage, there would be many levels of approval required, including changes to regulations, standards and guidelines, but we're interested in what the traffic engineering community thinks about this concept?
