IRMRC Research Report

MOTORCYCLE CRASHES INTO ROADSIDE BARRIERS STAGE 1: CRASH CHARACTERISTICS AND CAUSAL FACTORS

NSW Injury Risk Management Research Centre
(IRMRC)

March 2010

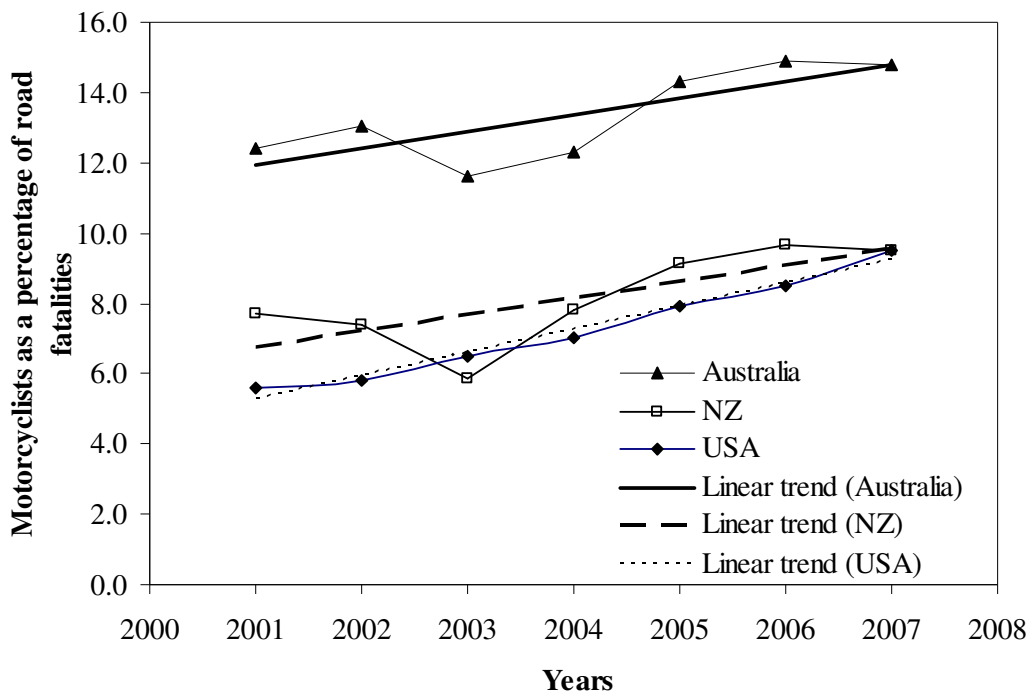
Figure 1: Motorcyclists as a percentage of all road fatalities in Australia, NZ and the USA
(Data sources: Australian Bureau of Statistics, NZ Crash Analysis System and US Fatality Analysis and Reporting System)

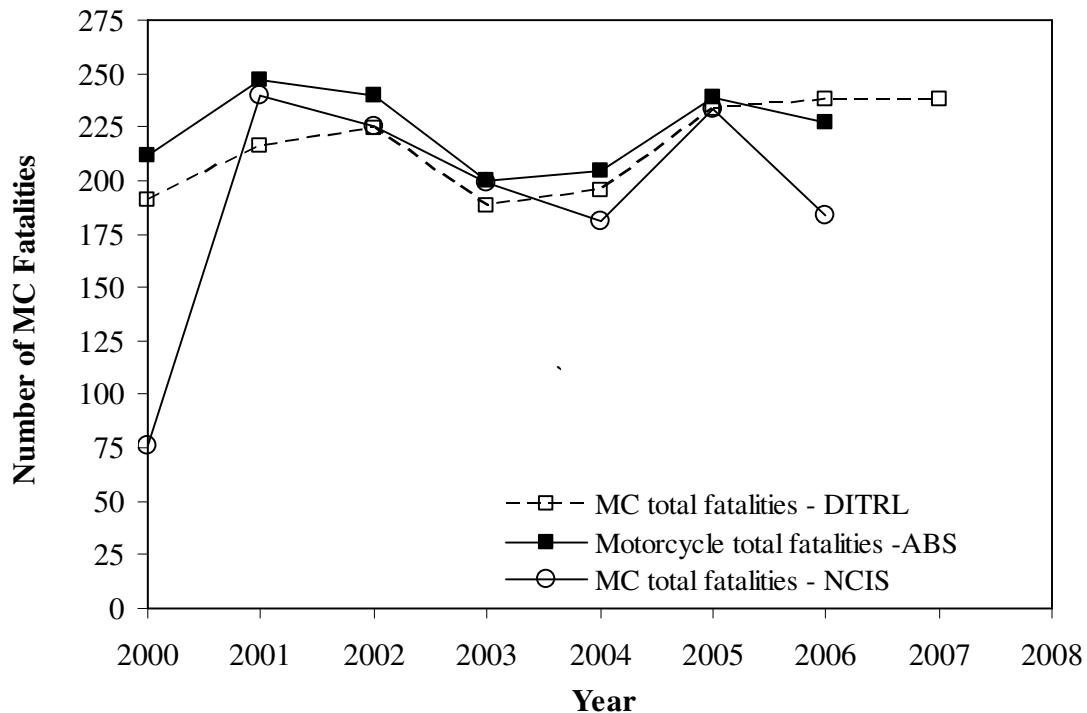
Figure 2: Comparison of fatal motorcycle crashes in Australian jurisdictions from various sources (2000 to 2007)

To gauge the reliability of the Australian data, the annual motorcycle deaths identified from the NCIS was compared to the motorcycle deaths recorded by the Australian Department of Infrastructure, Transport, Regional Development and Local Government (DITRL) and the Australian Bureau of Statistics (ABS). Figure 2 shows that the data extracted from the NCIS, DITRL and ABS were generally in agreement. However, the data from ABS consistently reported a slightly higher number of deaths than that from NCIS or DITRL. The NCIS data for 2000 and 2006 appear to stand out as being least consistent with the other databases. The NCIS began operations in June 2000 and the state of Queensland joined in January 2001, therefore the data in 2000 are incomplete. At the time the search was conducted, there were many 2006 cases still open resulting in the lower NCIS totals.

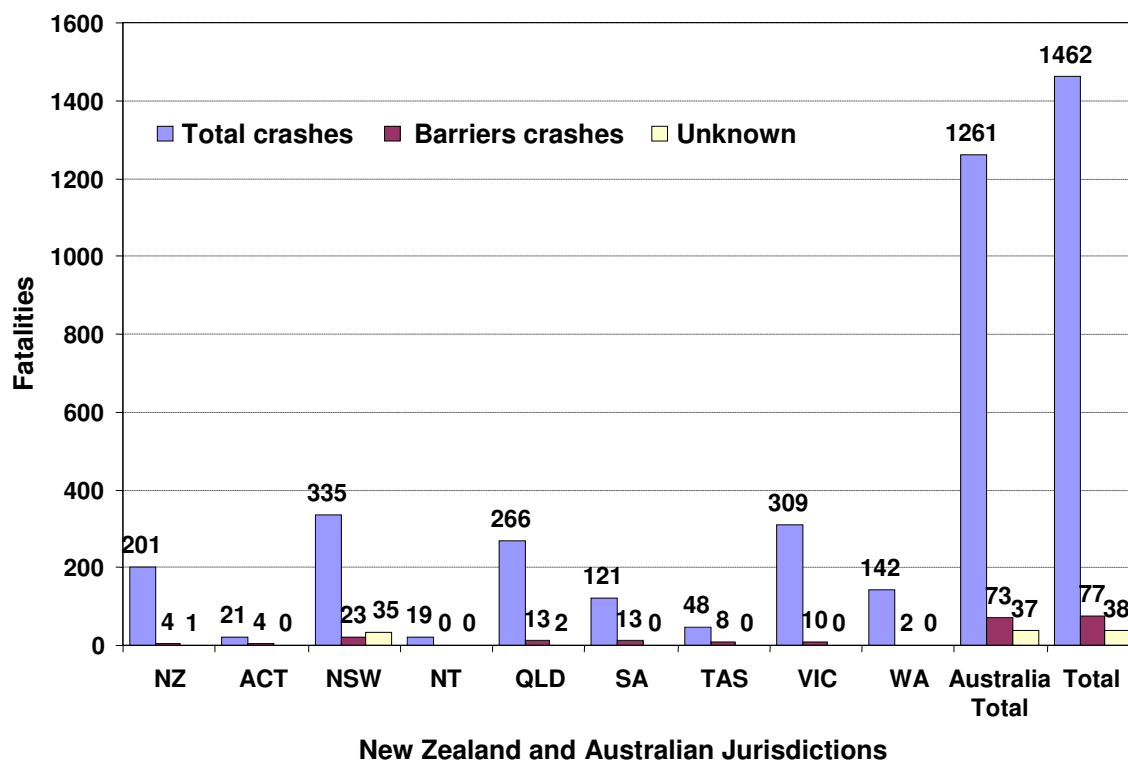
Figure 3: Fatal motorcycle crashes in Australian jurisdictions and New Zealand (2001 to 2006)

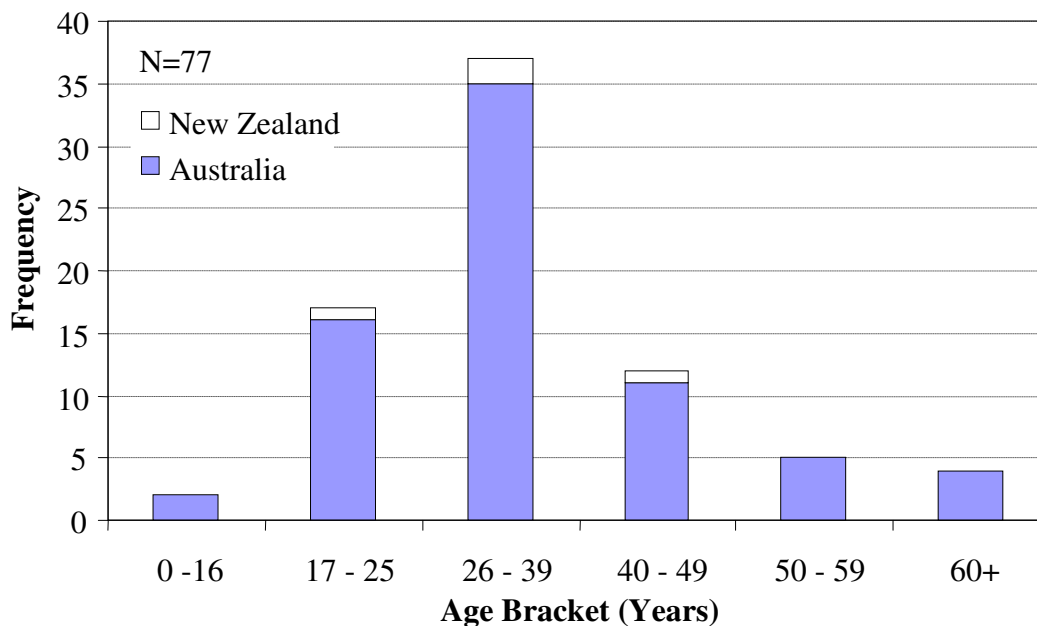
Figure 4: Age distribution of motorcyclist fatalities involving a roadside safety barrier in Australia and New Zealand (2001 to 2006)

Figure 4 shows the breakdown into age groups of motorcyclist fatalities involving a roadside safety barrier in Australia and New Zealand. The youngest and oldest persons killed were 11 and 70 years old respectively. The mean age was 34.2 years and the median was 31 years and 72.3% are aged less than 40 years. The largest group of motorcyclists killed as a result of a collision with a roadside barrier are aged between 26 and 39 years (48.4%). The 17 to 25 years age group was second highest consisting of 22.1%. The fact that riders in the 26 to 39 years age bracket are involved in the majority of the fatalities may be related to their crash risk and possible lack of experience (Harrison & Christie, 2005) but it also may be a reflection of the distribution of the motorcycle riding population. Unfortunately the national age distribution of the Australian motorcycling population was not available.

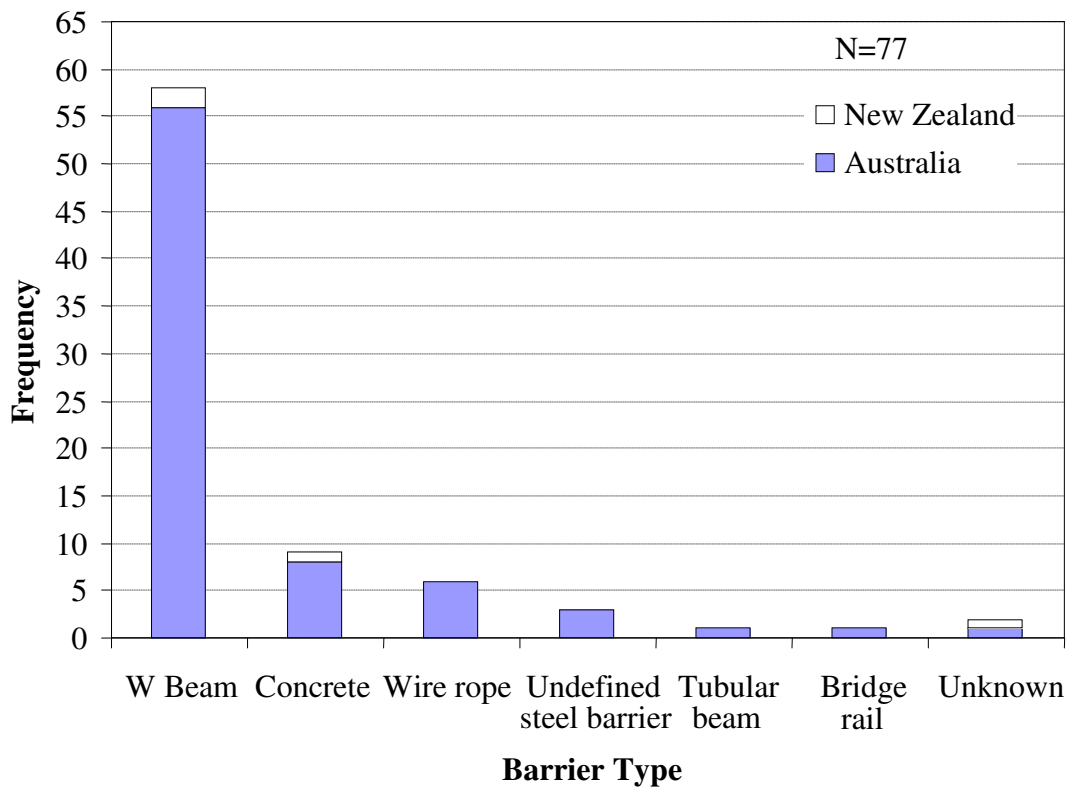
Figure 5: Roadside barrier types involved in motorcyclist fatalities in Australia and New Zealand (2000 to 2006)

Figure 5 shows that fatalities of motorcyclists involving impact with a roadside barrier predominantly involve W beams (72.7%). This was followed by concrete and wire rope barriers that accounted for 10.4% and 7.8% respectively. An additional 3.9% of impacts involved steel barriers, but there was insufficient information available to determine whether these barriers refer to W beams, Tubular or Thrie Beam steel barriers. These fatality proportions may be compared to the proportions of barriers installed (Table 3), which shows that: W beam comprises 71.5% of the barriers and results in 72.7% of the fatalities; concrete comprises 8.6% of the barriers and results in 10.4 % of the fatalities; and wire rope comprises 15.9% of the barriers and results in 7.8% of the fatalities. Therefore assuming the probability of a fatality occurring across the network of barriers is similar, wire rope barriers have around half the fatality rate of W beam barriers.

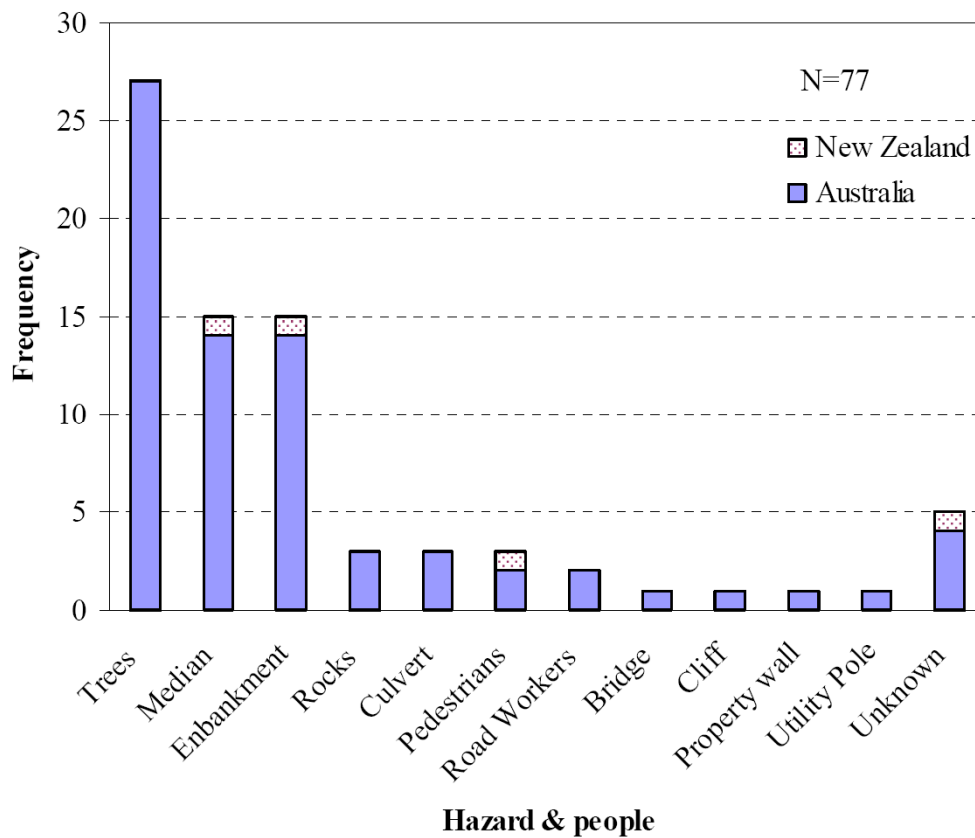
Figure 6: Hazards and people behind roadside barriers involved in motorcyclist fatalities in Australia and New Zealand (2001 to 2006)

Figure 6 shows the main hazards being protected by the barrier systems. Trees were the most common form of hazard being protected by the safety barriers (35.1%) followed by medians and embankments that were naturally occurring or created as a result of a raised roadway

with each constituting 18.2% of cases. Culverts, pedestrians and road workers each constituted a small number of cases where it was found road workers were protected using temporary concrete barriers. In 5.2% of cases, there was insufficient information to determine the hazard being protected against.

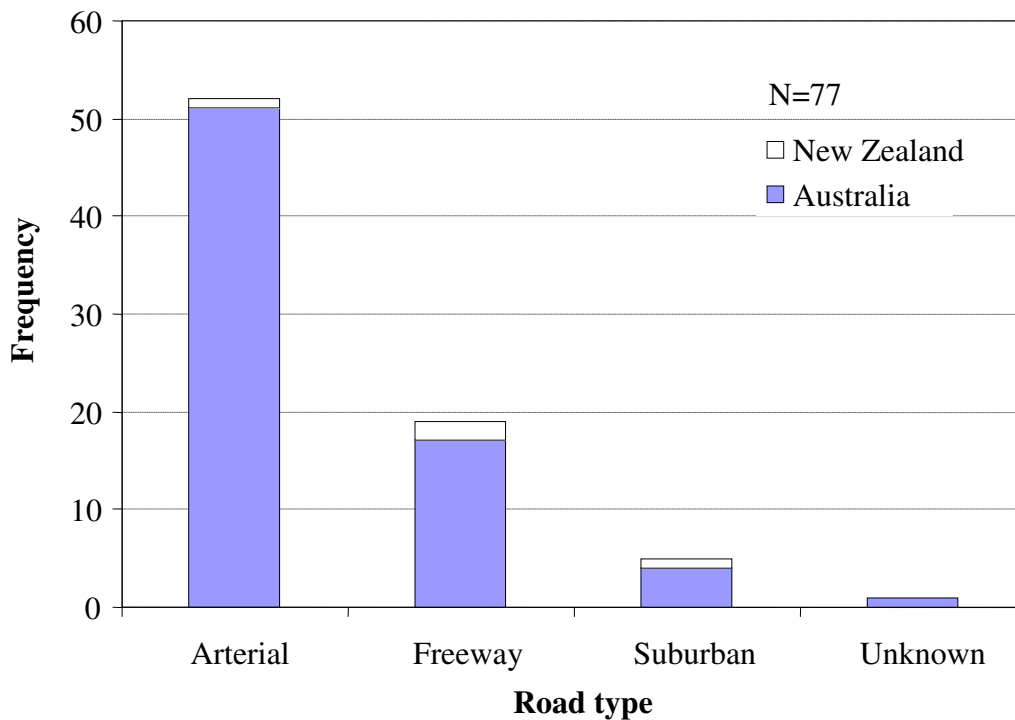
Figure 7: Road type in barrier impact resulting in a motorcyclist fatality in Australia and New Zealand (2001 to 2006)

Fatalities involving a motorcycle impacting a roadside safety barrier mostly occurred on roads with speed limits above 60 km/h. This is consistent with the findings of Gibson and Benatatos (2000). Figure 7 shows that the majority of the crashes occurred on arterial roads. Arterial roads were categorised as roads with speed limits ranging from 60km/h to 100km/h which consist of one or more lanes of traffic travelling in each direction with junctions. This distinguished them from freeways. Arterials accounted for 69.8% of the fatalities. Freeways with speed limits of between 100 and 110km/h accounted for 23.3% of cases. Freeways were categorised as roads which have 2 or more lanes travelling in the same direction with the traffic travelling in the opposite direction separated by a median barrier and no junctions but instead with exit ramps. Suburban roads with speed limits of between 50 and 60km/h accounted for only 5.5% of the fatalities.

It was possible to determine the speed limit applicable to the road in 72 cases. The largest number of fatalities occurred on roads with a speed limit of 100km/h (37), followed by 80km/h (22) and 60km/h (10). The observed difference between road types is probably a reflection of differences in the extent of barrier exposure and also the effect of speed on crash severity. Barrier installation is less likely on suburban roads than on arterial roads and dual carriageway freeways. More fatalities occur on higher speed roads since a fall from a motorcycle at high speed is associated with higher energy that has to be dissipated than a fall at a lower speed.

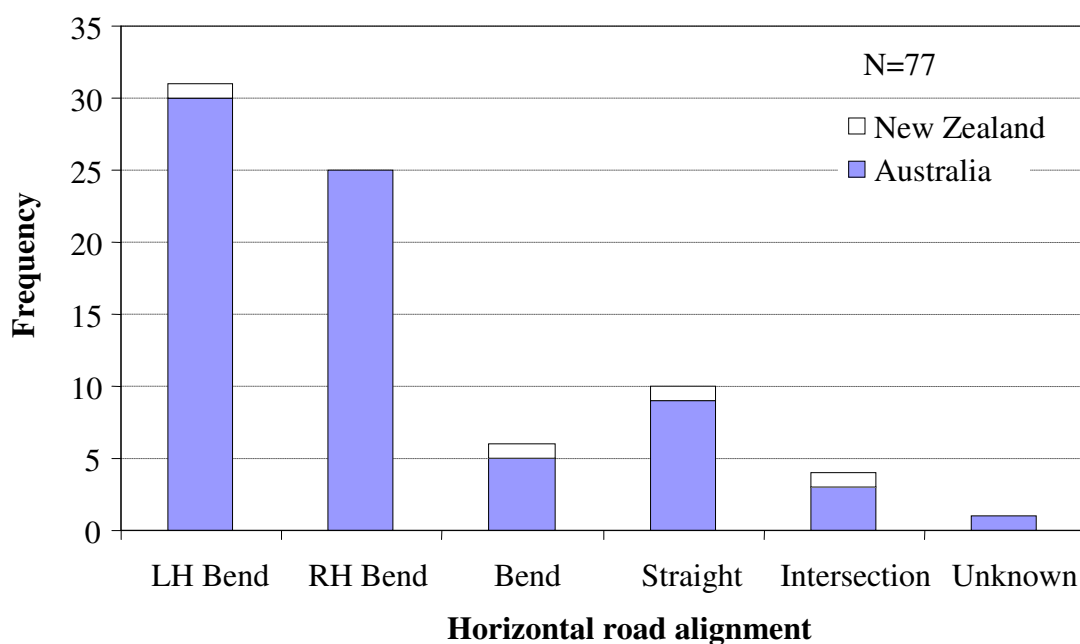
Figure 8: Horizontal alignment of roadside barrier impacted resulting in a fatality in Australian jurisdictions and New Zealand (2001 to 2006)

Figure 8 shows the horizontal alignment of the road site where a motorcyclist died and where an impact into a roadside barrier was involved. 80.8% of fatal crash sites involved a bend in the horizontal alignment of the road. Nearly an equal number of cases involved a left hand and right hand bend with 28 and 26 cases involved respectively. A further 8 cases were described only as a bend. Unfortunately, there was insufficient information in the records to determine the radius of the curvature of the bends involved. Only 14.1% of cases occurred on a straight section of the road and 3.8% occurred at an intersection.

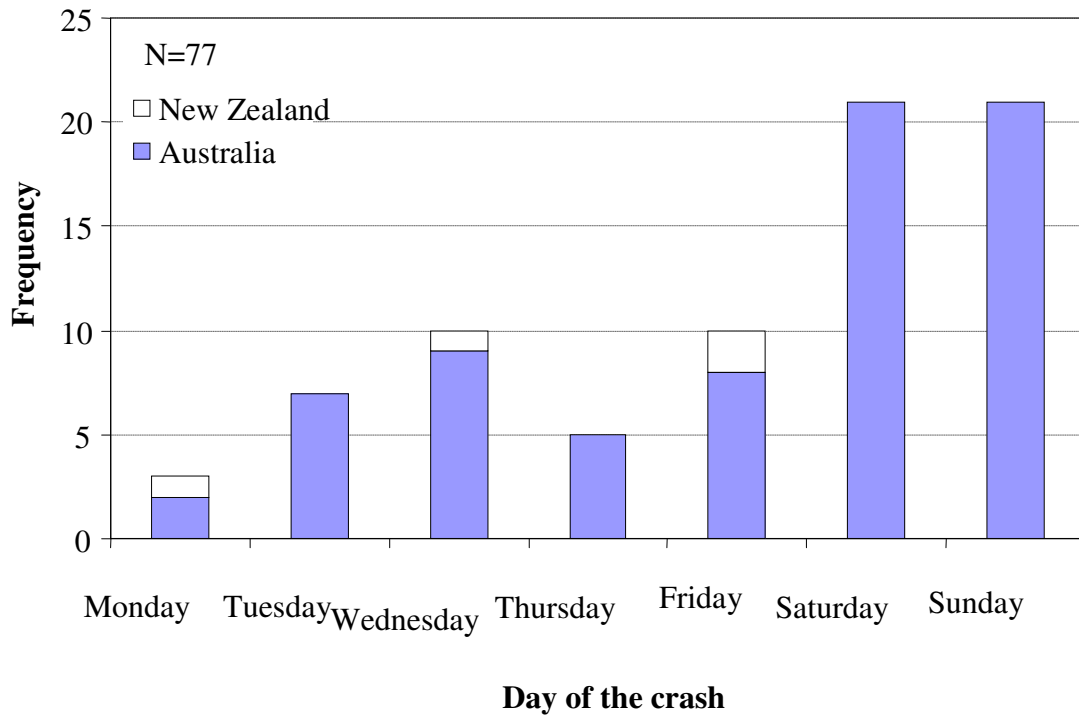
Figure 9: Day of the crash of motorcyclist fatalities involving impact into a roadside safety barrier in Australia and New Zealand (2001 to 2006)

Figure 9 shows that 54% of motorcycle fatalities involving a roadside safety barrier occurred on a weekend, with 21 fatalities associated with each day. The rest of the week witnessed 35 fatalities with an average of 7 deaths for each day. In 46 cases motorcyclists were on a recreational ride, which explains the high frequency of fatalities on a weekend. Driving as a recreational activity is generally known to be a predictor of crashes (Clarke, Ward, Bartle & Truman, 2006; Gregersen & Berg, 1994).

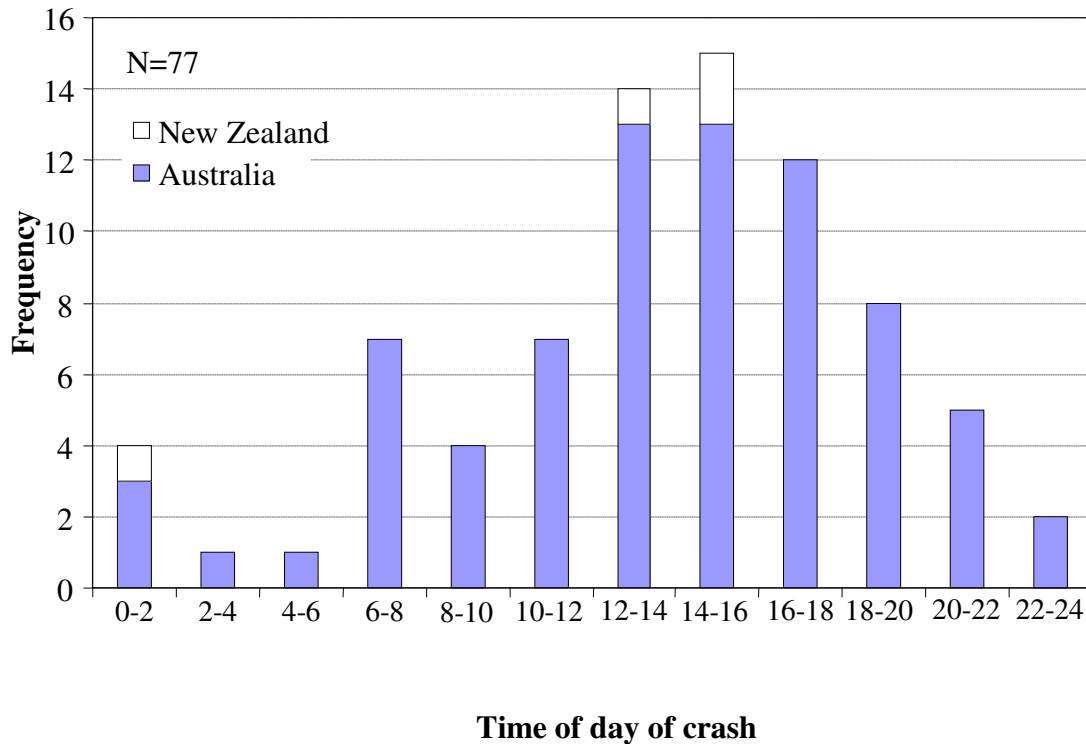
Figure 10: Time of Crash of motorcyclist fatalities involving impact into a roadside safety barrier in Australia and New Zealand (2001 to 2006)

Figure 10 shows that barrier crashes primarily occurred during daylight hours, particularly in the afternoon. This pattern probably reflects exposure, with riders more likely to engage in recreational riding in the afternoon, but it may also be related to fatigue as the recreational riders are likely to be returning from a ride later in the day and may be tired.

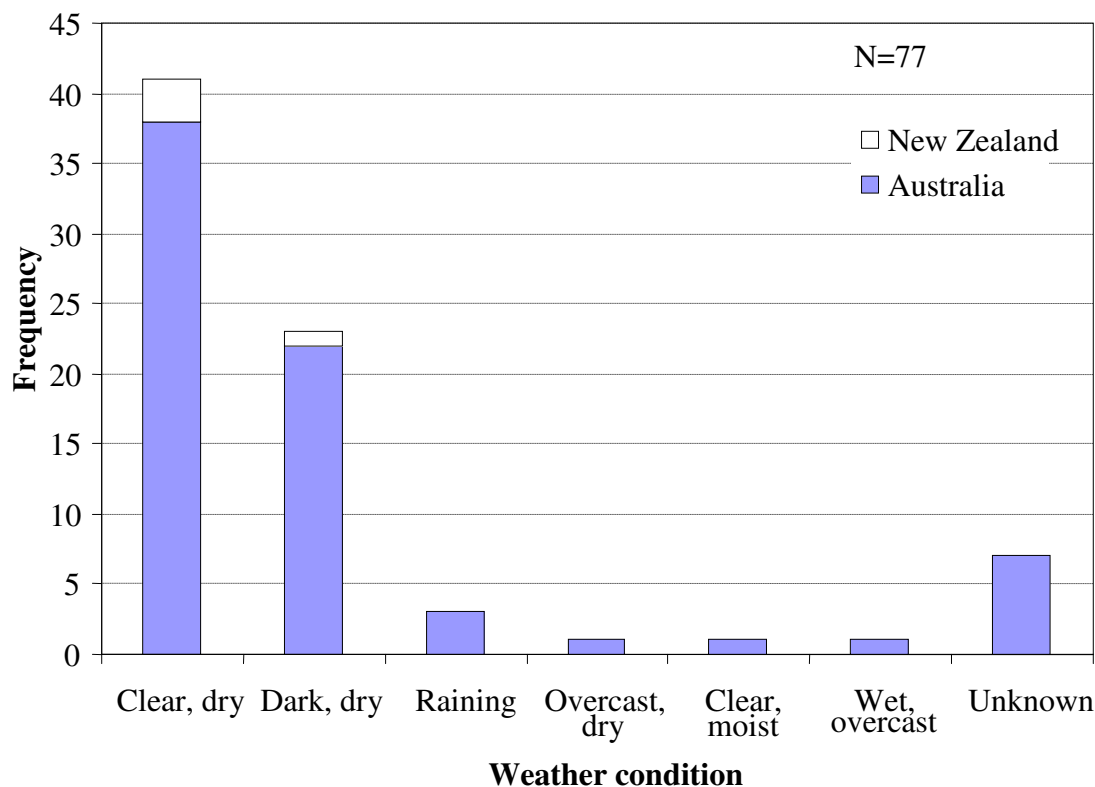
Figure 11: Weather condition at the time of a crash involving a motorcyclist fatality and a roadside safety barrier in Australia and New Zealand (2001 to 2006)

In nearly half of the cases, the weather was described as “clear and dry” or “fine day” and the road surface condition was dry (Figure 11). This was followed by dark conditions with dry road surface in which 28.2% of the fatalities occurred. In 16.7% the description of the weather was insufficient. These results are not surprising as dry conditions are conducive to riding a motorcycle. The authors suspect that the lower numbers for wet conditions reflect exposure, i.e. riders chose not to ride in wet or rainy conditions.

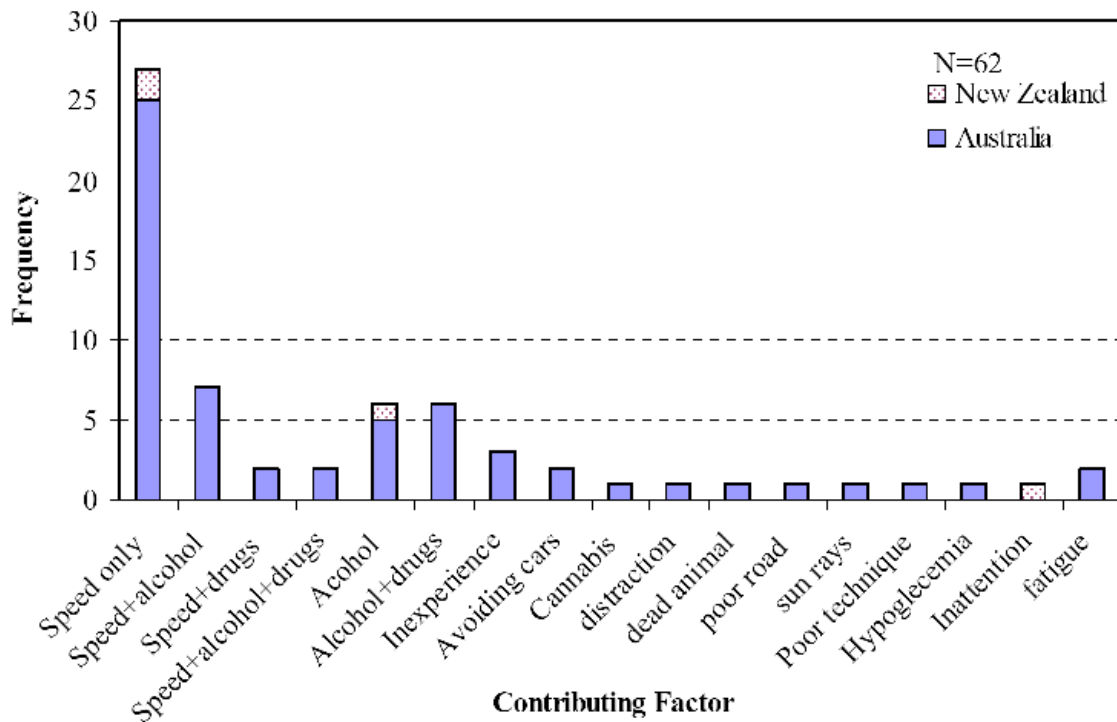
Figure 12: Crash contributory factors of motorcyclist fatalities involving a roadside safety barrier in Australia and New Zealand (2001 to 2006)

A summary of the main factors that contributed to the crash were isolated from the police reports (Figure 12). Speeding or inappropriate speed was found to be the highest single factor

that contributed to the crash (27 cases). Alcohol by itself, closely followed by alcohol with a combination of speed (7) and drugs (6) was also a common contributory factor. Other factors such as avoidance of vehicles and fatigue did not feature highly as contributory factors.
