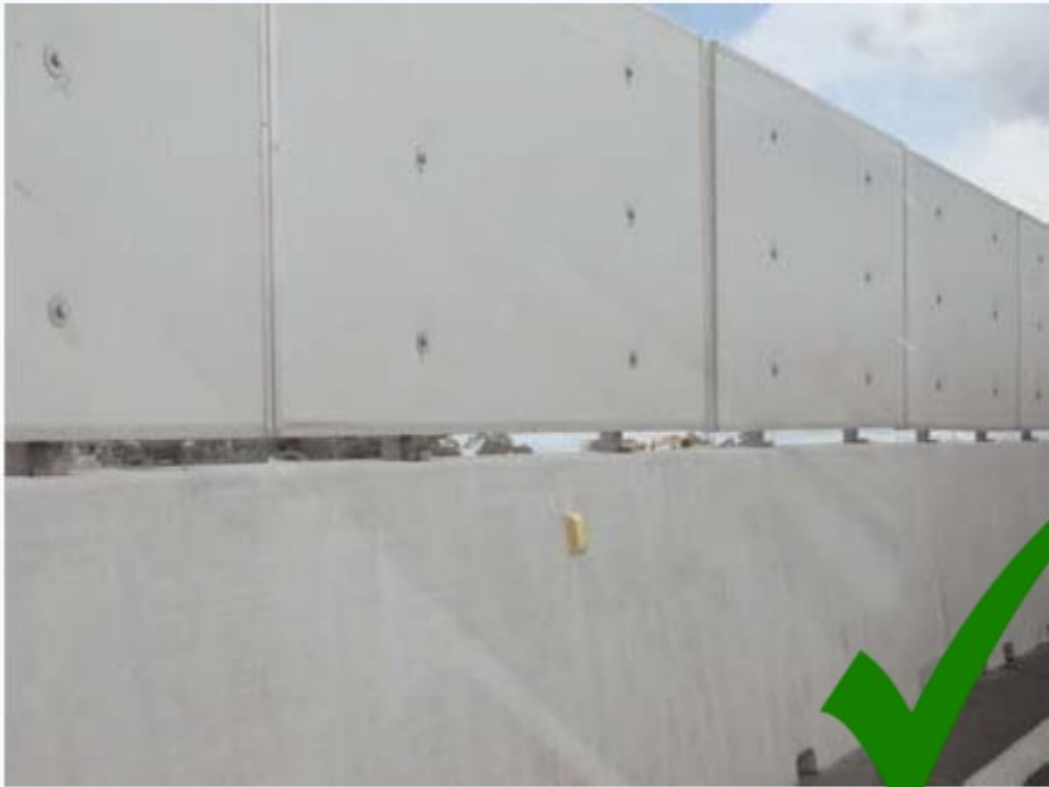
Product is neat, tidy and effective.
Note that vertical alignment is achieved by correct use of stabilising wedges inside the stanchion holes.

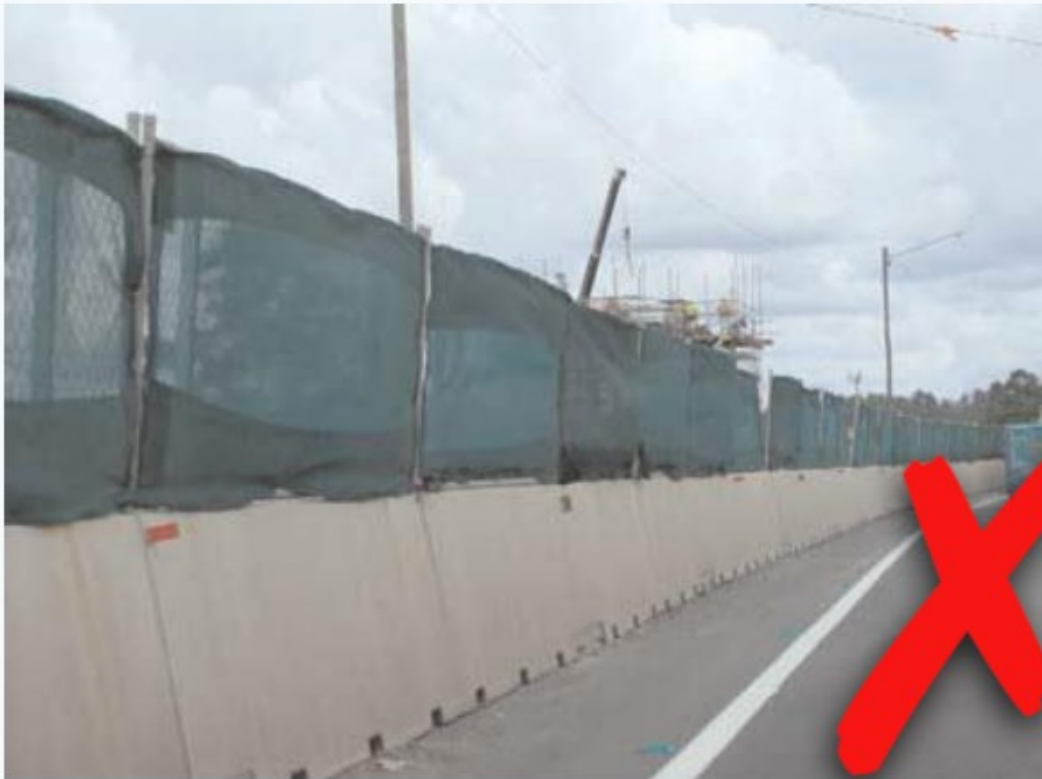
Product is distracting and poorly presented.
Shade cloth solutions rarely result in an
effective screen.

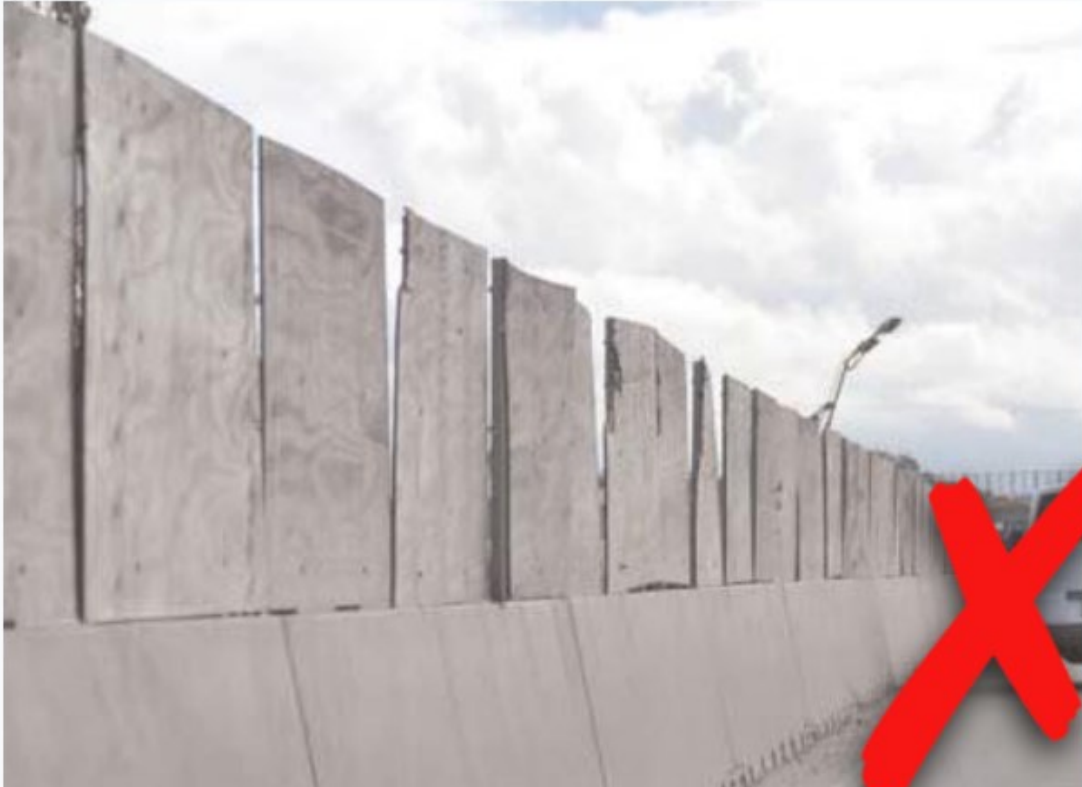
Timber panels need to be maintained, especially when installed for longer periods.

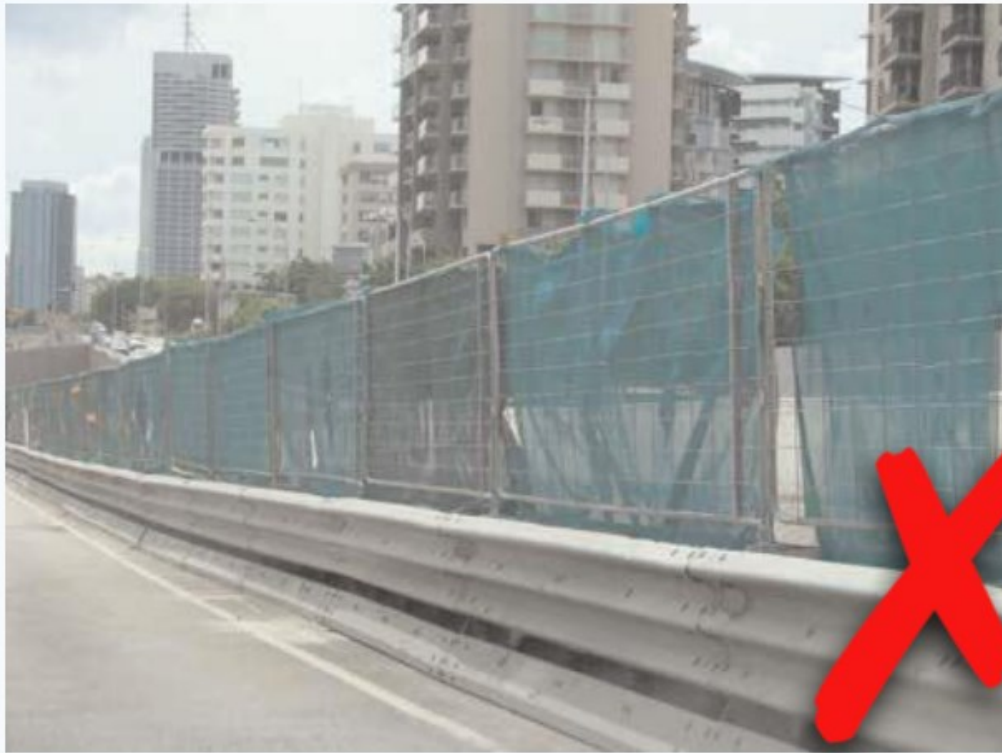
Temporary fence panels mounted on a steel barrier system. It is unlikely that the method of mounting is approved by the barrier manufacturer and could compromise the barrier performance. Horizontal rails constitute a potential spearing hazard and are not permitted.

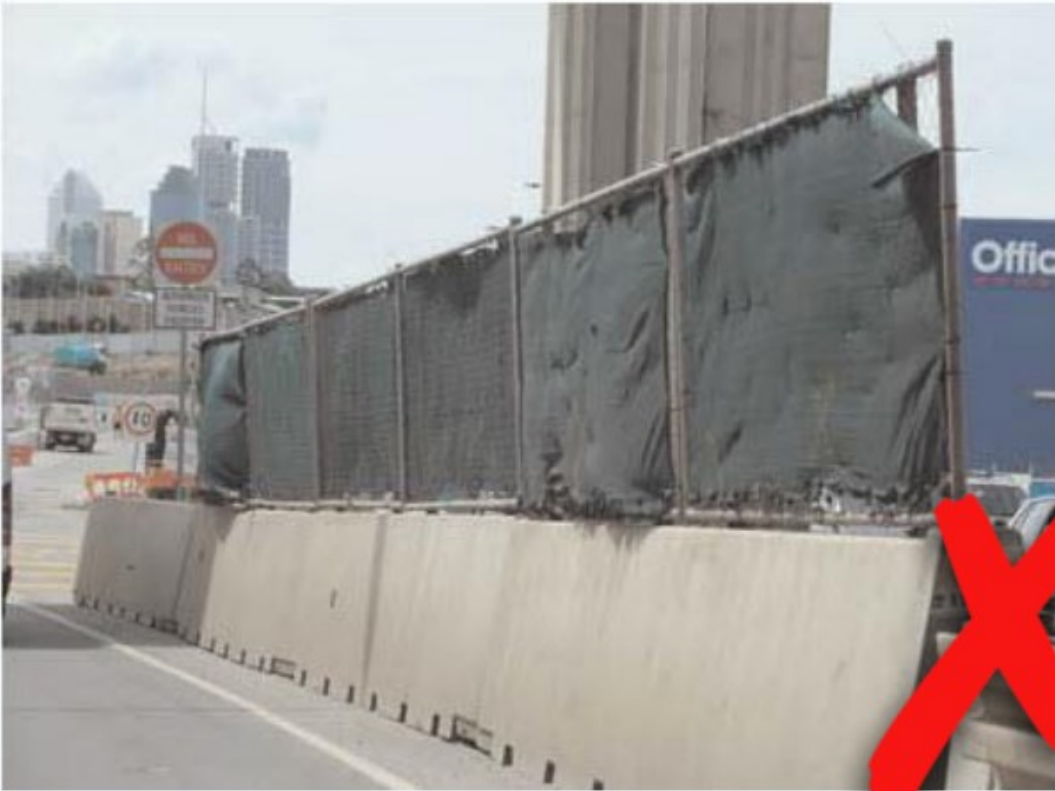
Temporary fence panels mounted on PCBs.
Horizontal rails constitute a potential spearing
hazard and are not permitted.
